**Pacojet: shaft stuck in extended (down) position;
beaker cannot be removed! No problem as it can be
wound up back to starting position by hand as follows:**

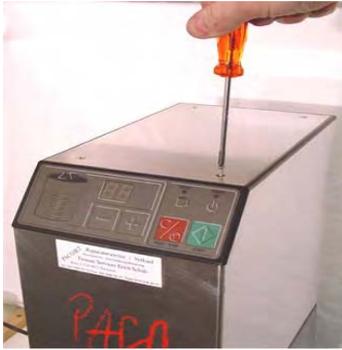
Remove metal top plate (4 screws)

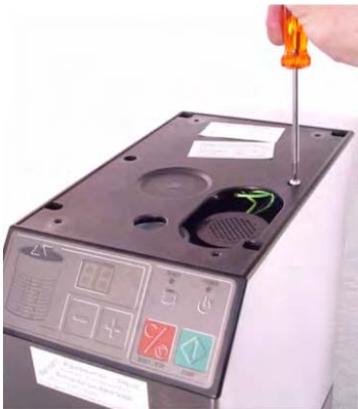
**Remove the 6 sunken screws
of black plastic top cover.**

Note: should one of the middle screws be covered by a **red** or **blue** plastic cap, pry (prise) it out with a pointed object.

Note: removal of **red** color plastic cap requires prior approval of Pacojet AG as otherwise removal will void the warranty (pls. telephone +41-41-7102522 and advise serial number, which can be found on floor plate (bottom) of the machine (turn it upside down to see the 10 or 11 digit number (big numerals) on the specification label).

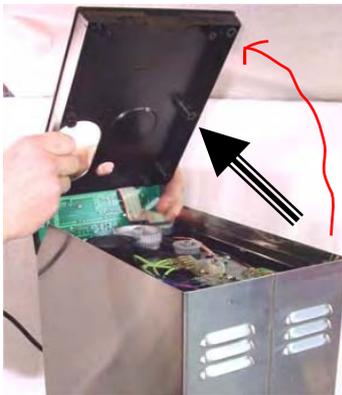
Next, grasp top cover at back side and gently lift it up as shown

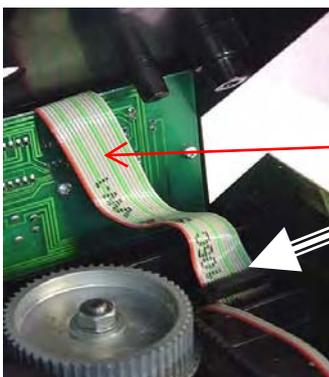
Do not unplug the flat band (ribbon) cable. Let the top cover hang from this cable, alongside of the metal housing (casing).

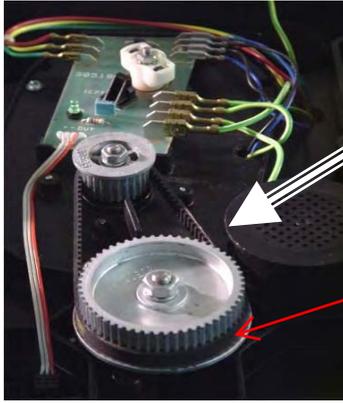
Remove toothed belt from front pulley wheel.

If necessary, use a flat screw driver to pry (lift) the belt up and off the **front** belt wheel

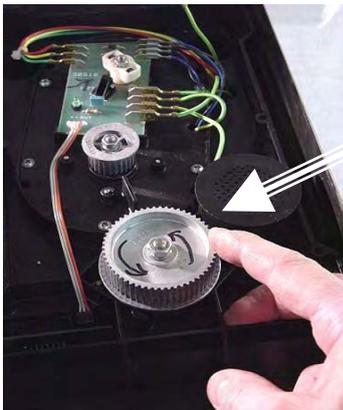
With your finger, turn the belt wheel **counter-clockwise**.

Note: possibly the belt wheel will be hard to turn for the first few rotations. Don't give up! Keep turning and the shaft will gradually rise. Keep turning until the shaft is all the way up/wheel turns no further. When you feel resistance, stop. Do not exert force

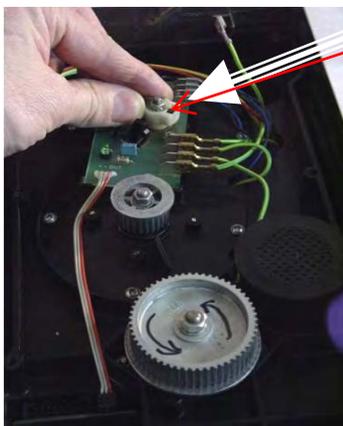
Should the ~~white plastic speed pulser~~ (sits on the ~~pcb~~ at the back) turn as well, just hold it in place with your free hand
